騒音レベル 測定結果

測定個所、測定点	青南建設(株)青梅工場No.1(工場操業時)
測定年月日	平成23年10月7日
測定時刻	9:03-9:18

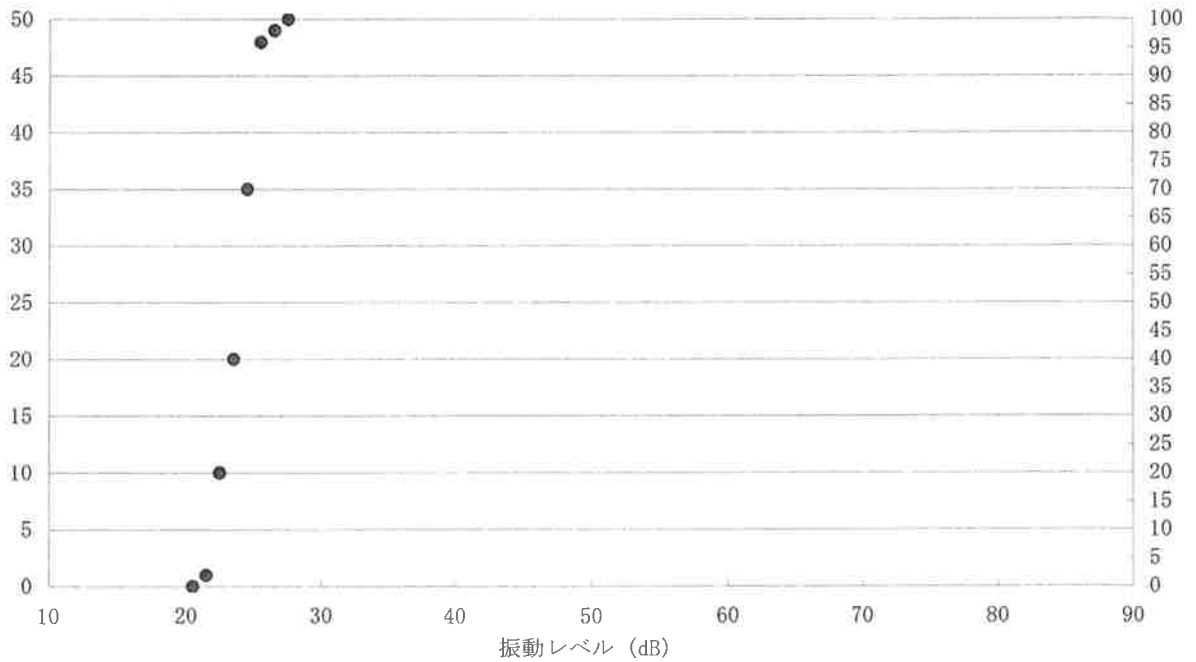
【累積度数曲線図】

測定箇所、測定点	青南建設(株)青梅工場No. 2(工場停止時)
測定年月日	平成23年10月7日
測定時刻	11:02-11:07

L10	L50	L90
25	24	22

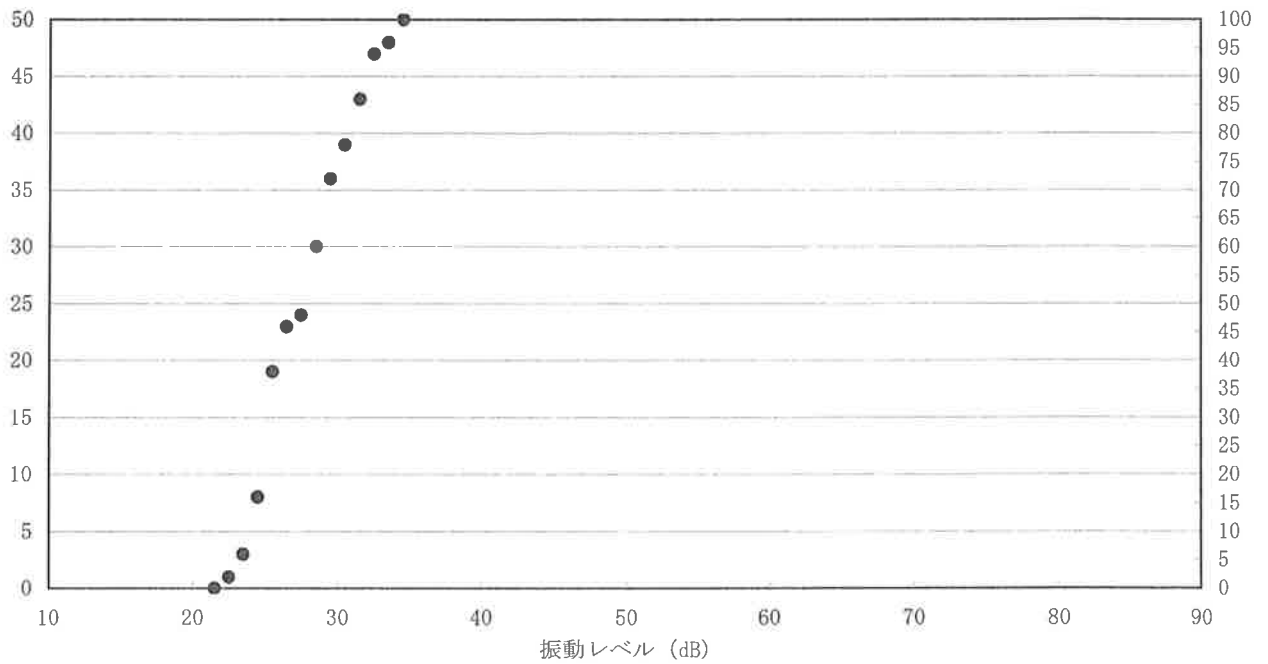
【累積度数曲線図】

測定箇所、測定点	青南建設(株)青梅工場No.3(工場停止時)
測定年月日	平成23年10月7日
測定時刻	10:02-10:20

L10	L50	L90
32	28	24
